High-Fire-Resistance Glulam Connections for Tall Timber Buildings

This report provides a brief overview of relevant results as required by one of the project sponsors Smart Housing Småland. The project consists of 4 timber connection fire resistance tests and 4 tests of similar connections at room temperature. A more detailed discussion of the tests of connection 3 and 4 is given in the Master Thesis of Ronstad and Ek (2018).

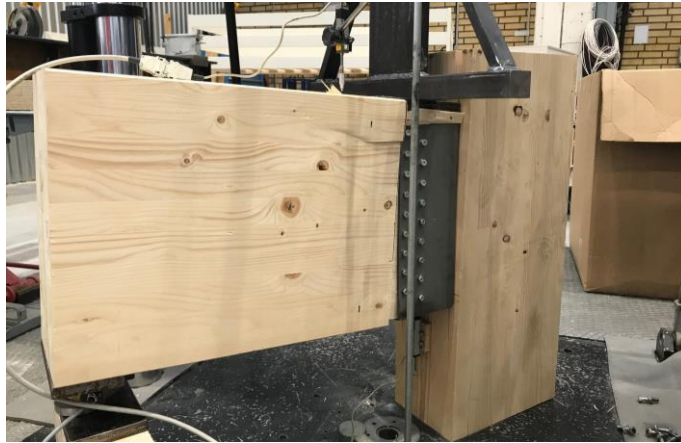
Figure 5: Connection 1 after room temperature test

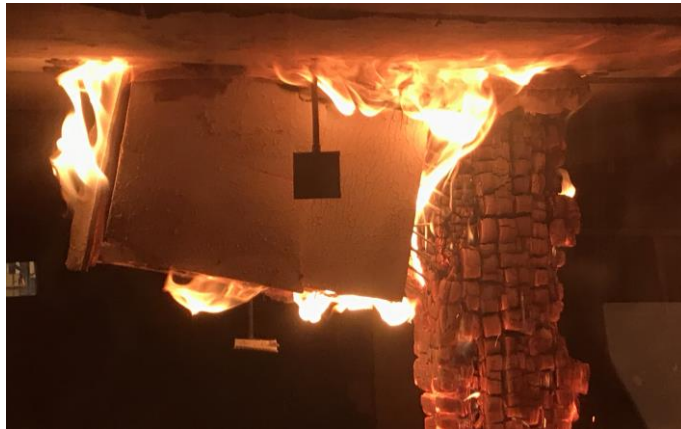
The measured temperatures of the steel members at the time of failure ranged between 350 and 480°C, indicating that the timber around the steel screws was close to these temperatures and started to char. The picture of the beam cross-section (Figure 7) shows that also in the beam, the screws started to cause charring deeper in the timber. This indicates that embedment failure occurred, which is confirmed by video evidence. Pictures taken after the room temperature test and the fire test are shown in Figure 5 and 6, respectively. Annex A shows the technical drawings deflection and steel temperatures of connection 1.

Figure 6: Connection 1 fire test 10 minutes after failure

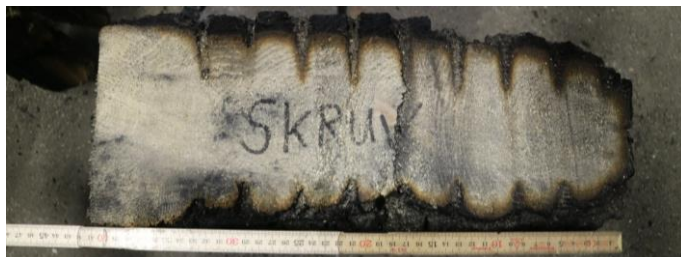
Figure 7: Photo of cross-section of beam with charred screw holes.

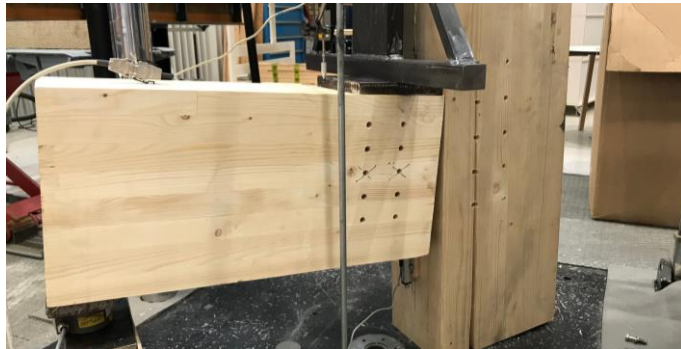
Pictures taken after the room temperature test and the fire test are shown in Figure 10 and 11, respectively. The average 1-dimensional charring rate determined by thermocouples was 0.7mm/min. And the measured temperatures of the steel members at the time of failure ranged between 95 and 150°C at the moment of failure, with the majority of measurements around 100°C. Due to the rate of temperature increase near the end of the test, it is however, not expected that the connection would have remained intact for another 20 minutes to achieve a higher fire resistance rating than 90 minutes if the support would not have failed.

Figure 10: Connection 1 after room temperature test

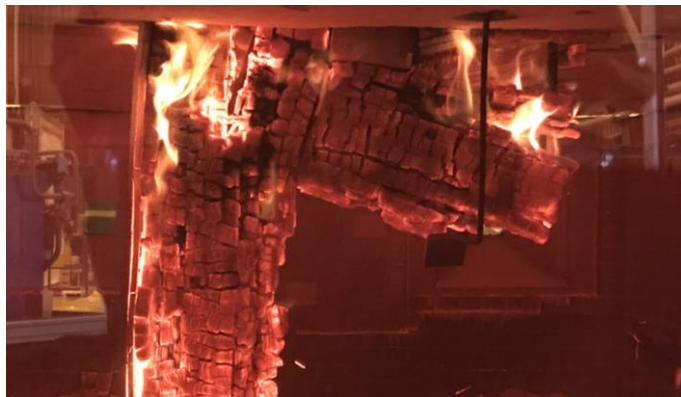
Figure 11: Connection 2 fire test 6 minutes after failure

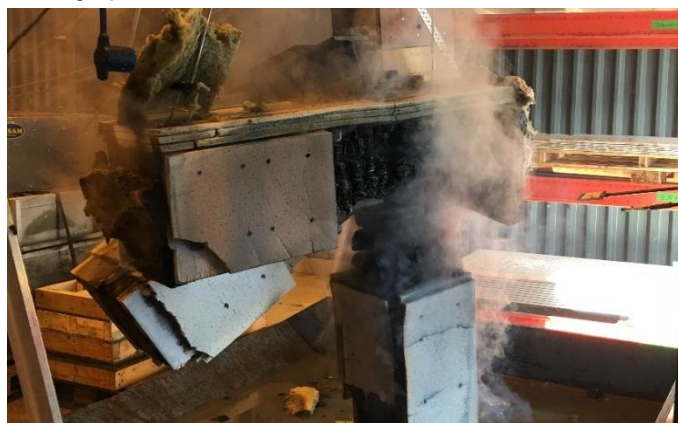
The connection itself did not fail at the end of the test. Therefore, it is relevant to discuss the likelihood of the connection having a higher fire resistance based on analysis. Three different types of failure modes are assessed:

The weakest link in the tested structure (apart from the end support that failed) is the column. Being exposed from 3-sides, the reduced cross section of the column reduces rapidly. Depending on the structural design, the column will likely fail before the connection fails.

Figure 13: Specimen after the fire test (end support failed)

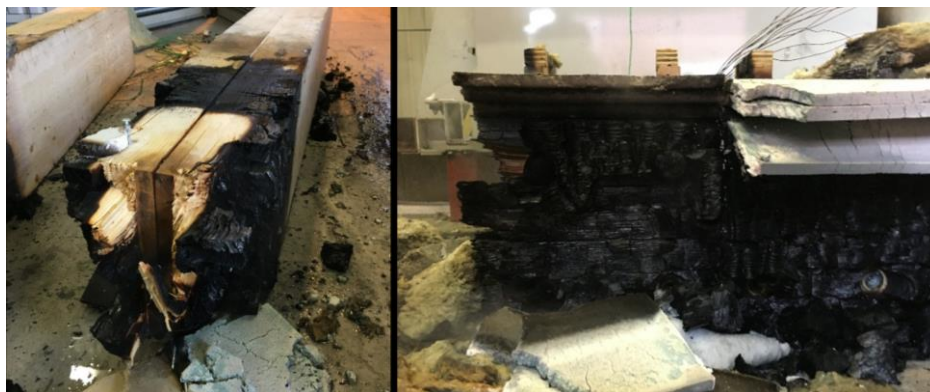
Table 5 shows an overview of results. The first failure occurring during the fire test at the smallest cross-section of the beam but did not involve the connectors, DVW plates or the flitch plate. It is therefore expected that a small increase of the beam cross-section would have resulted in a fire resistance classification higher than R60. The temperature of the tubes near the shear plane was 50 to 70°C, indicating no embedment failure occurred or would occur within the next few minutes.

Figure 16: Specimen after the fire test – failure mode: bending failure at the minimum cross-section

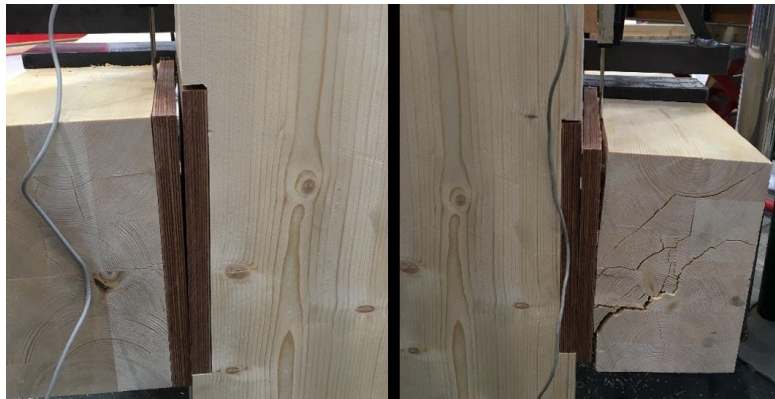
Figure C3: the failure mode for high shear forced.

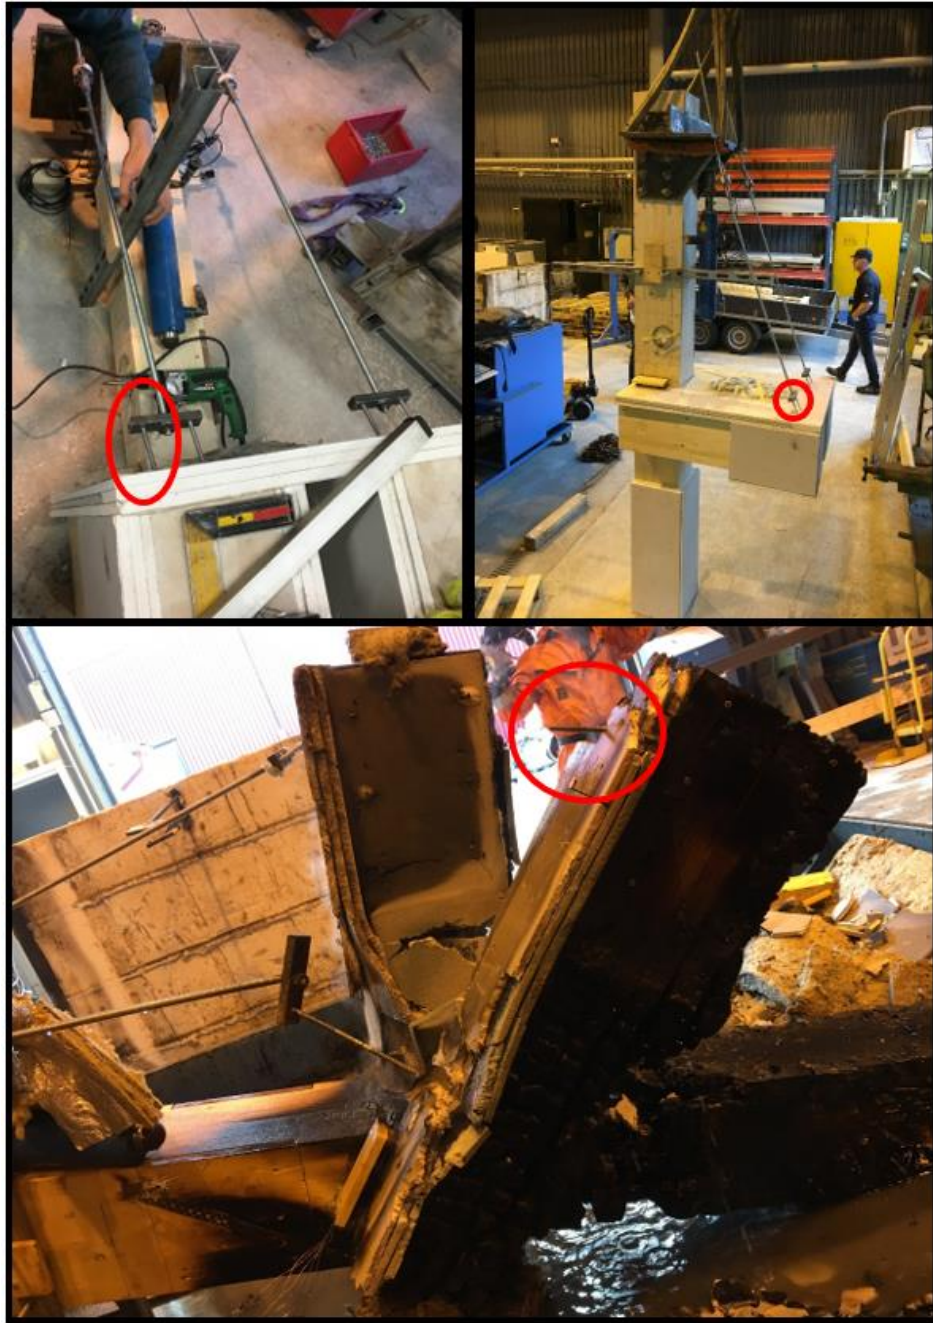
Figure C5: Location of support failure (from Ronstad and Ek, 2018)

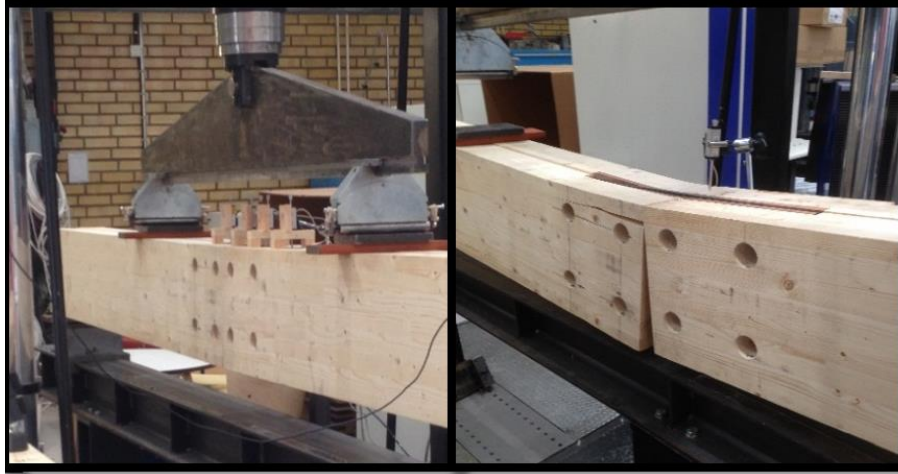
Figure D2. Photos during and after test

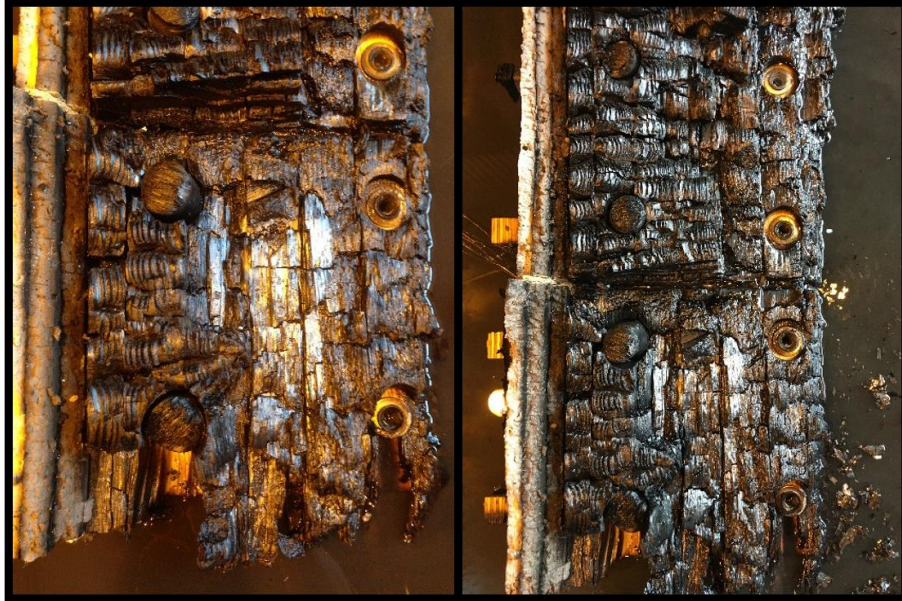
Figure D7. Tubes after the test without a sign of damage
